REPORT
FOR
HARBOR CONSULTANTS, INC.
ATTN: MR. VICTOR VINEGRA, PRES.
444 PINE AVE.
GARWOOD, NJ 07027

TO CONDUCT A NON-TIDAL WETLAND DELINEATION ON A TRACT DESIGNATED
AS: BLOCK 294, LOTS 3,15 AND 14, KEARNY, NJ.

PREPARED BY:
NOVA CONSULTANTS LTD.
251 BURGUNDY LANE
NEWTOWN, PA 18940

SEPTEMBER 1990

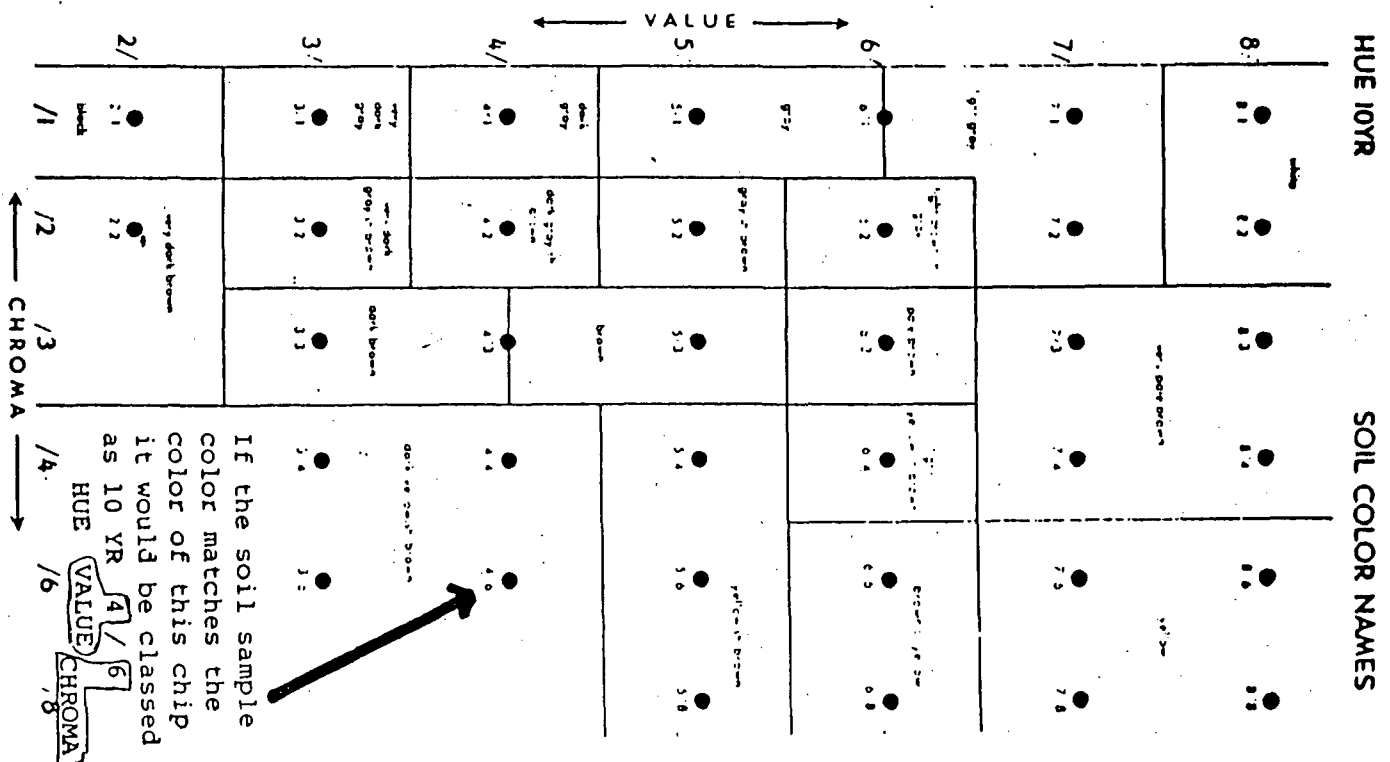
The HUE notation is taken from the one of the nine cards used. The 20-30 color chips on each card are numbered in a vertical/horizontal grid. The vertically numbered rows of chips constitute the VALUE while the horizontally numbered rows of chips become the CHROMA. See sample below.

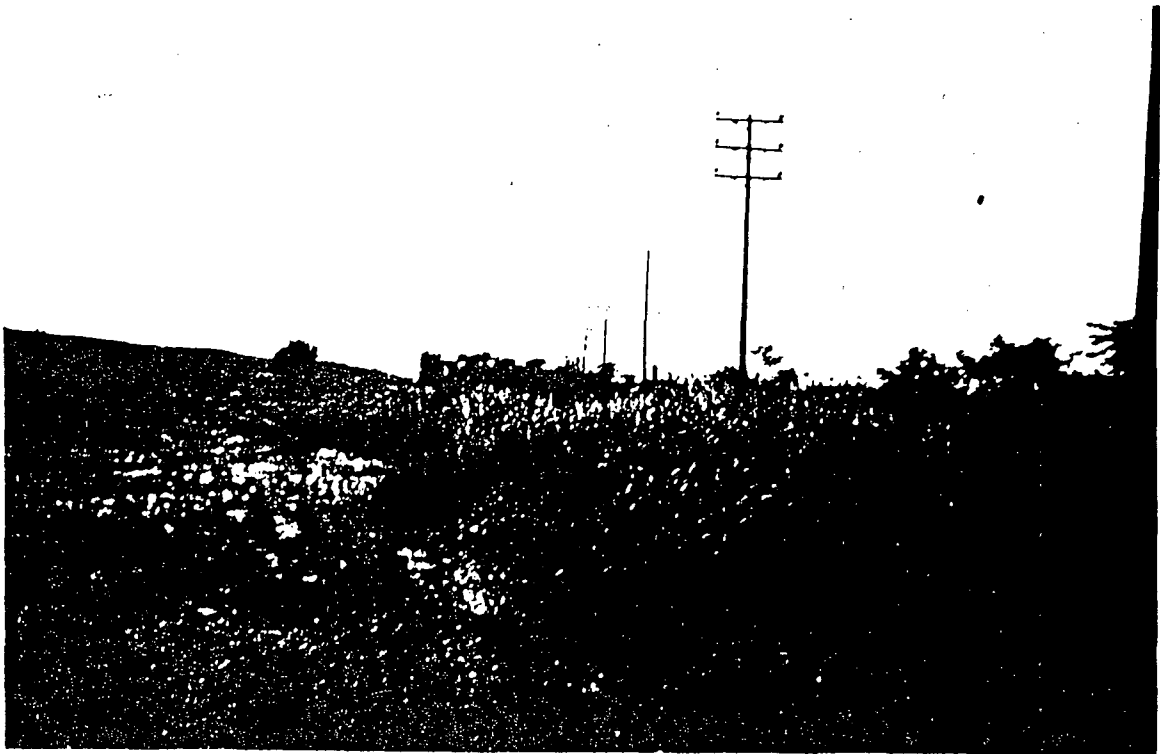
PHOTO-1

PHOTO 1 (P-1) VIEW LOOKING SOUTH ALONG WESTERLY BOUNDARY WITH THE P.S.E. & G. ELECTRIC R.O.W. TAKEN WITHIN NORTHERLY BOUNDARIES.

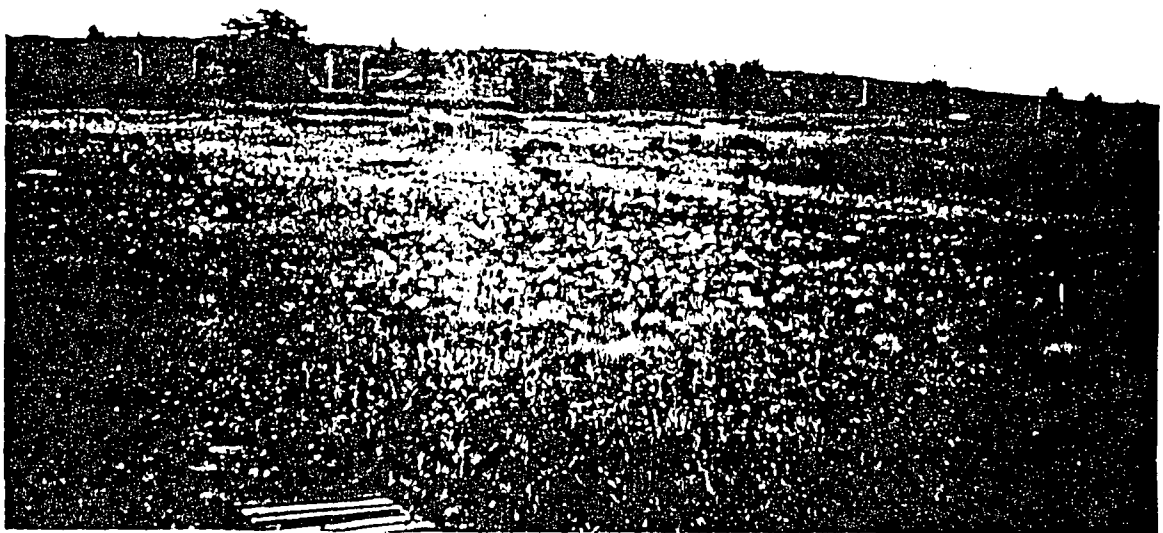
PHOTO-2

PHOTO 2 (P-2) SOUTHEASTERLY VIEW LOOKING ACROSS THE CENTRAL PORTION OF THE SITE P.O.W. AREA REAR OF VIEW AT TREE LINE, TAKEN ALONG THE NORTHERLY SITE BOUNDARY AREA.

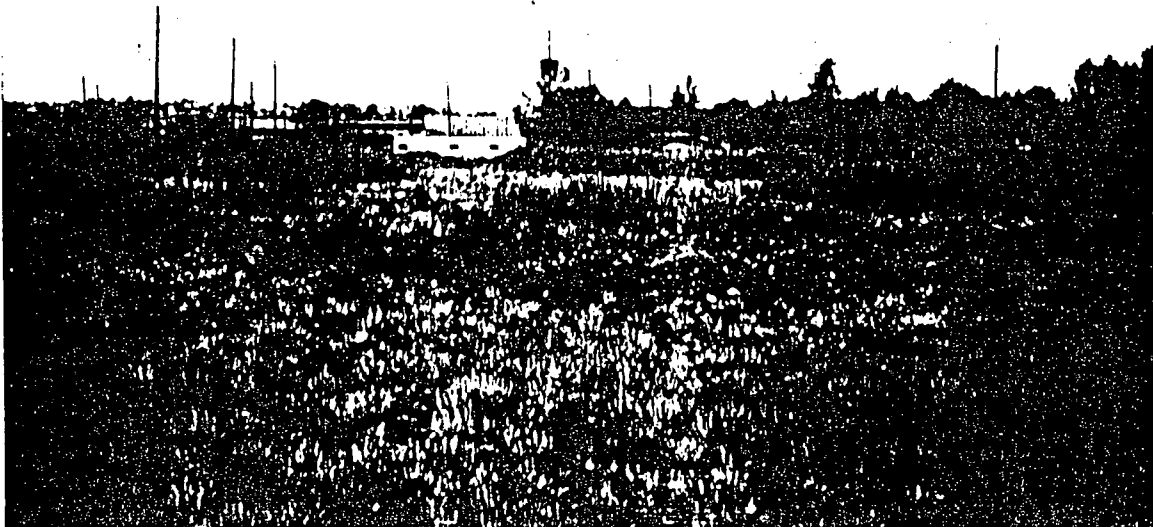
PHOTO-3

PHOTO 3 (P-3) NORTHERN DIRECTIONAL VIEW LOOKING TOWARD THE NEWARK AND JERSEY CITY TURNPIKE EXHIBITING FALLOW UPLAND FIELD CHARACTERISTICS WITHIN PREVIOUSLY FILLED AREA.

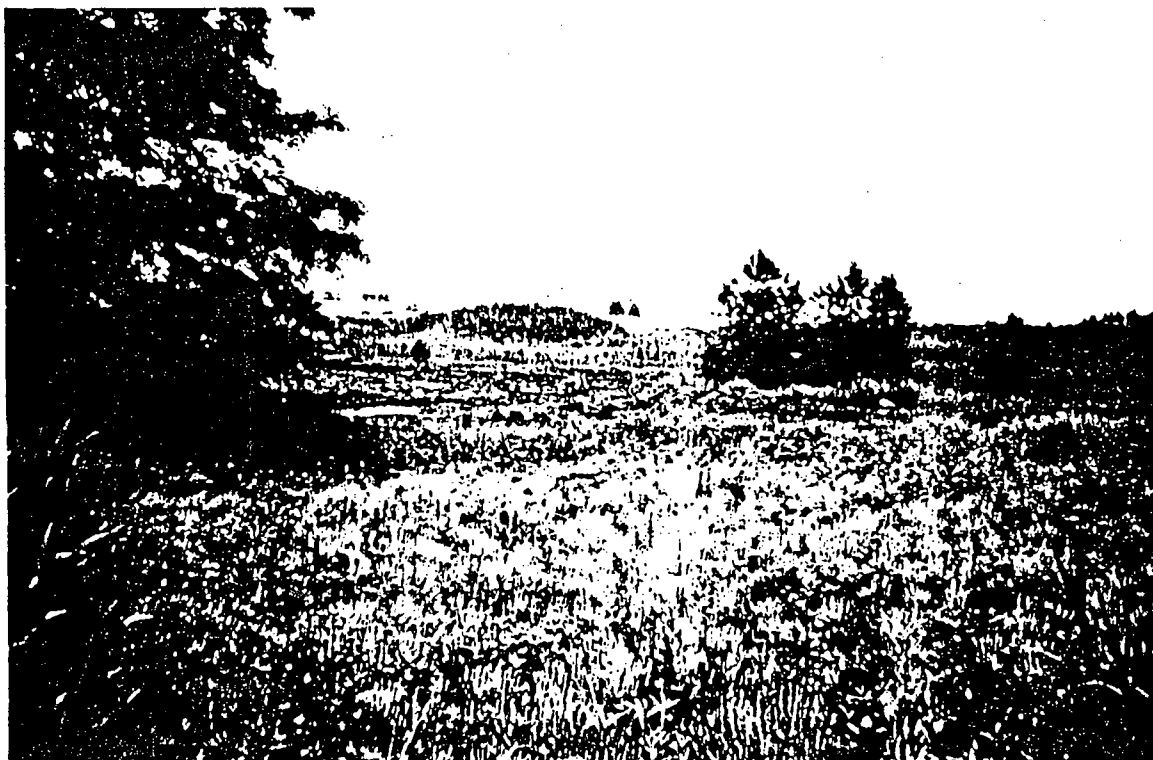
PHOTO-4

PHOTO 4 (P-4) VIEW LOOKING NORTHEASTERLY TOWARD CORNER OF TRACT. FOREGROUND AND MIDDLE GROUND VIEW UPLAND FALLOW FIELD PREVIOUSLY FILLED. MIDDLE VIEW AREA REVEALS PONDING RESULTING FROM IMPERMEABLE FILL MATERIAL.

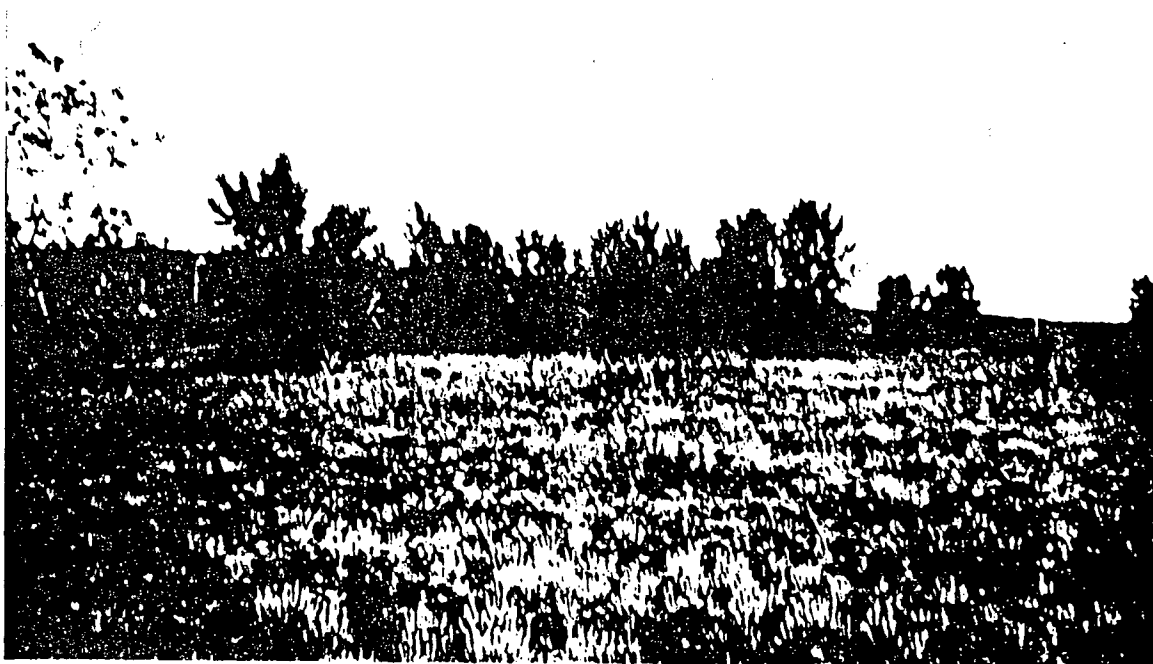
PHOTO-5

PHOTO 5 (P-5) UPLAND AREA VIEW OF FALLOW FIELD CONDITIONS. P.O.W. AREA 'A' MIDDLE REAR OF VIEW AT FARTHEST TREE LINE LOOKING SOUTHEAST.

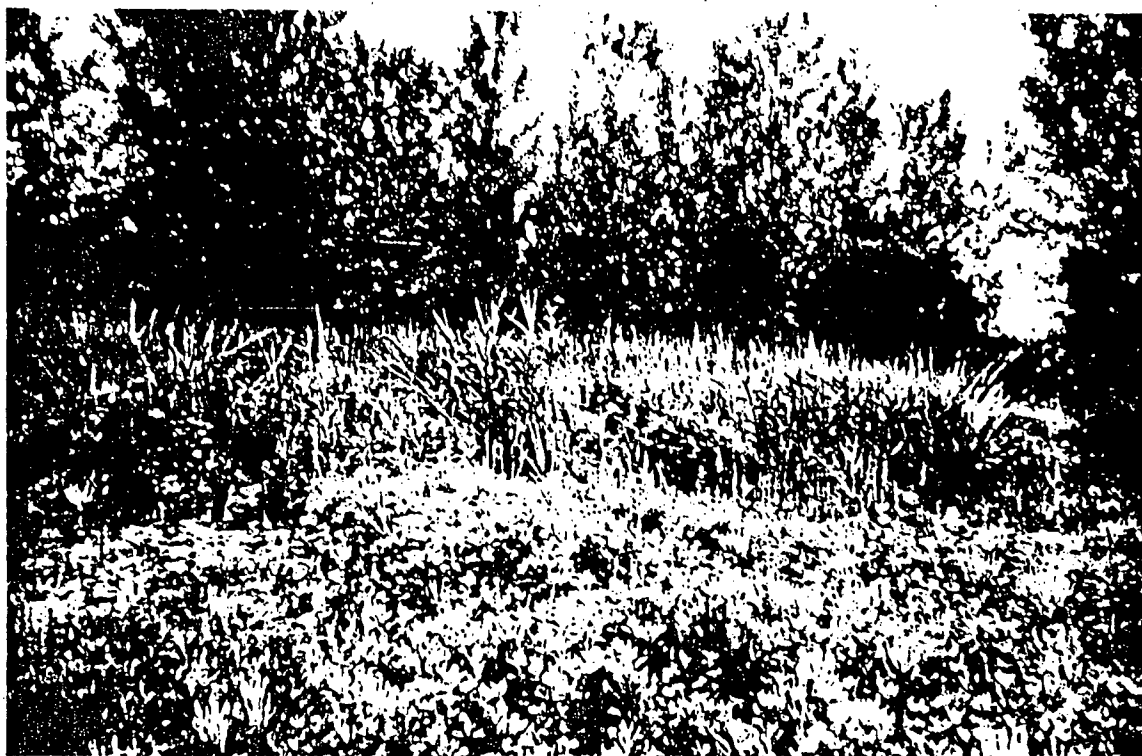
PHOTO-6

PHOTO 6 (P-6) SIMILAR DIRECTIONAL VIEW AS P-5 SHOWING DISTURBANCE CREATED BY UNCONSOLIDATED FILL ALONG THE NORTHERLY LIMIT OF WETLAND AREA 'A' (P.O.W.) NEAR FLAGPOINT A-3 TAKEN ABOVE THE DELINEATED LINE.

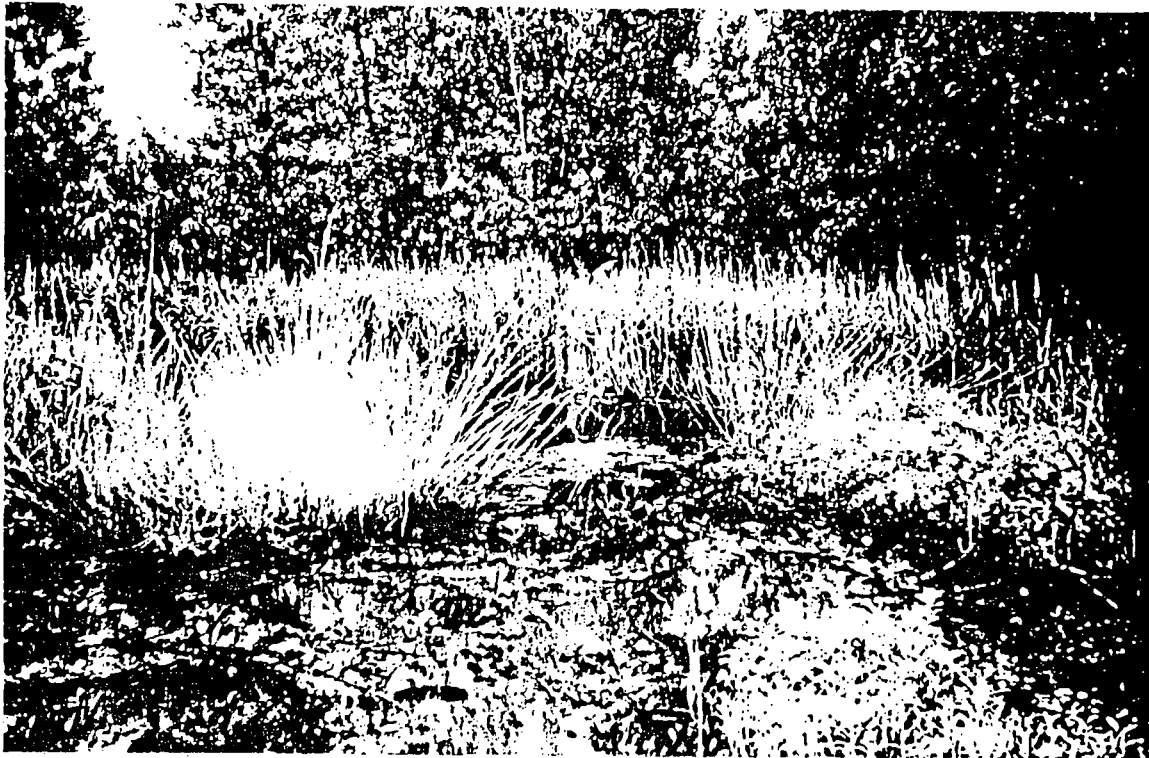
PHOTO-7

PHOTO 7 (P-7) VIEW LOOKING IN SIMILAR DIRECTION WITHIN WETLAND AREA 'A' MINOR VARIATIONS OF PALUSTRINE HABITAT CONDITIONS WITHIN THIS MAJOR P.O.W. SUBSYSTEM.

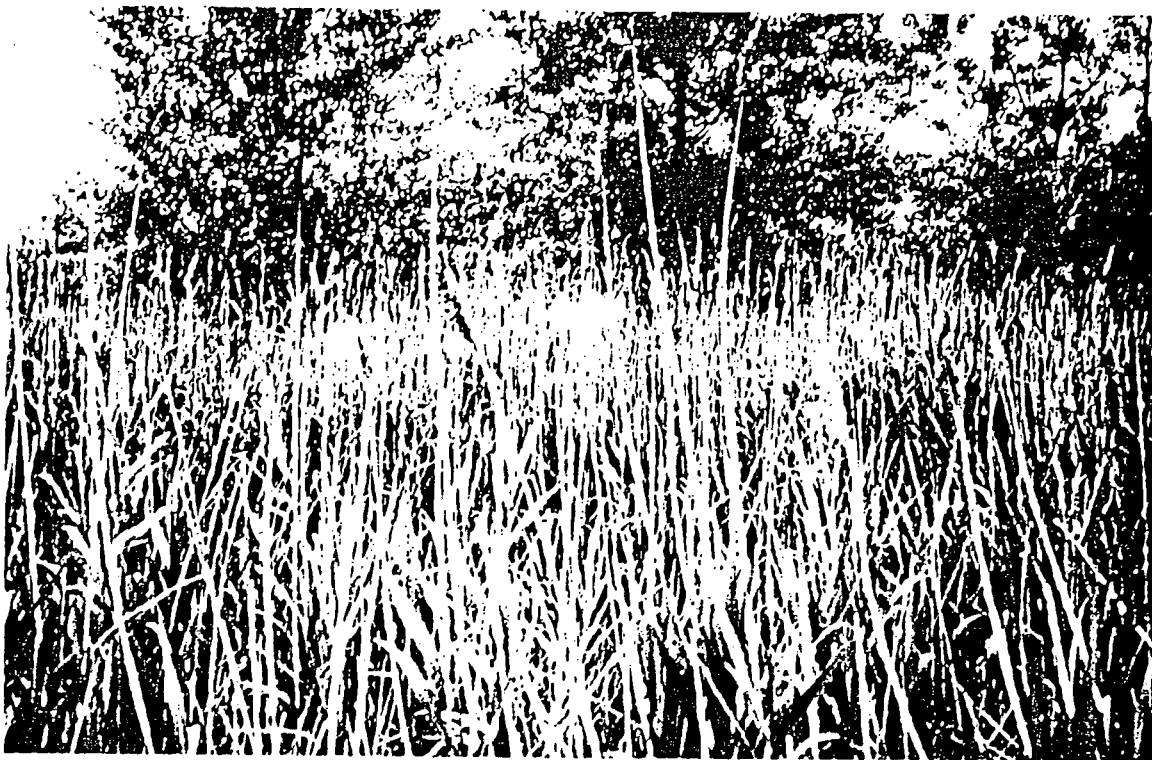
PHOTO-8

PHOTO 8 (P-8) EASTERLY VIEW LOOKING TOWARD NJ TURNPIKE HIGHWAY BERM SHOWING PEM HABITAT CONDITIONS WITHIN WETLAND AREA 'A' AND LOOKING TOWARD FLAGPOINTS 54-55.

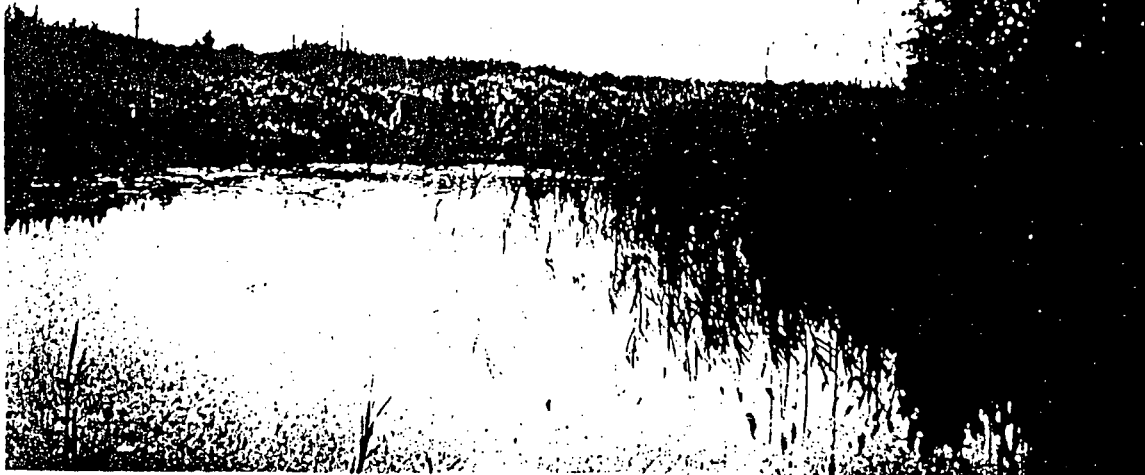
PHOTO-9

PHOTO 9 (P-9) NORTHERLY DIRECTIONAL VIEW SHOWING P.O.W. WETLAND AREA 'A' AND AREA OF PREVIOUS UNCONSOLIDATED FILL SURROUNDING THE AREA TO THE WEST OF THE POND.

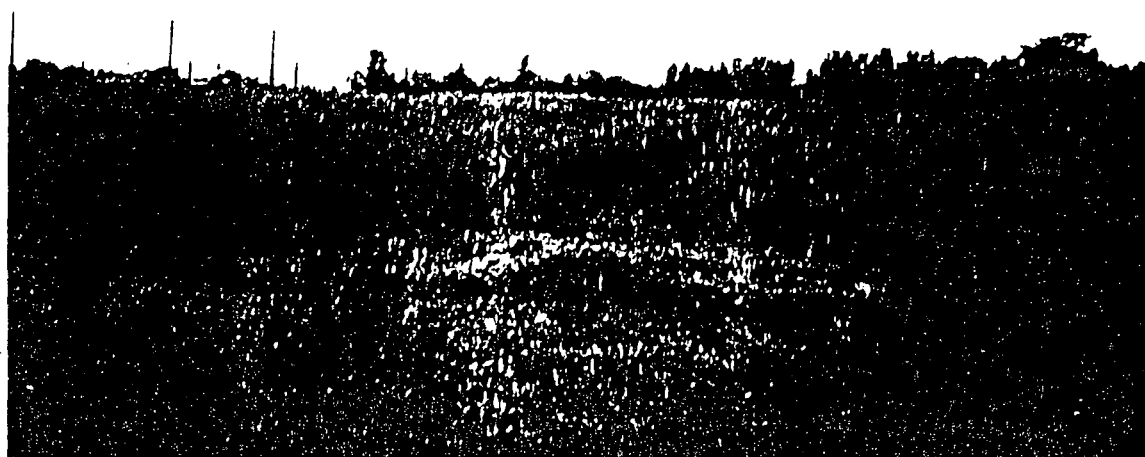
PHOTO-10

PHOTO 10 (P-10) UPLAND AREA OF FALLOW FIELD LOOKING TOWARD THE NORTHWEST CORNER OF THE TRACT.

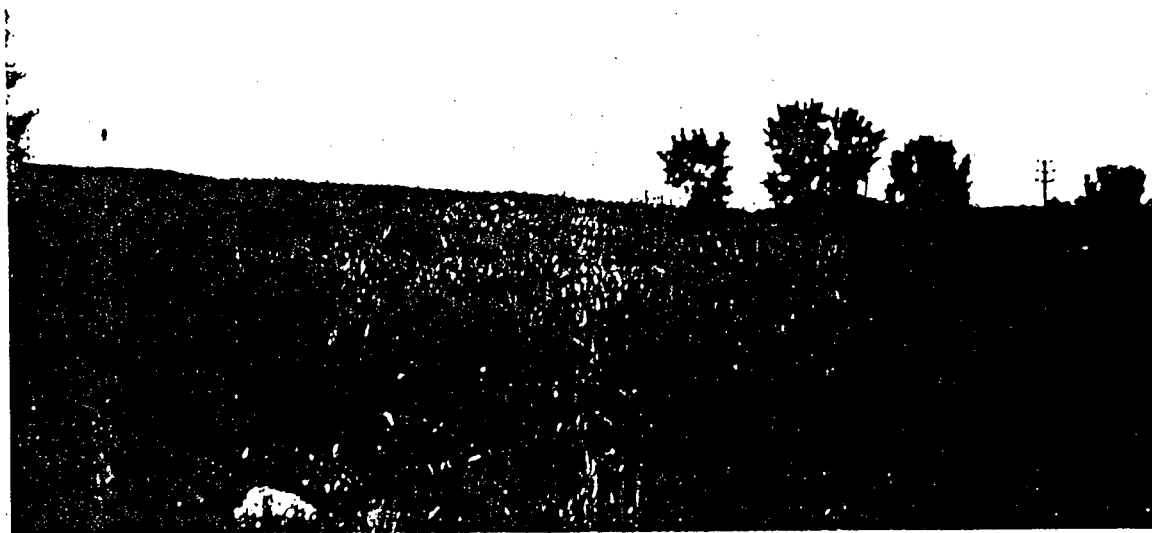
PHOTO-12

PHOTO 12 (P-12) SIMILAR UPLAND VIEW LOOKING TOWARD THE SOUTHWEST CORNER OF THE TRACT.

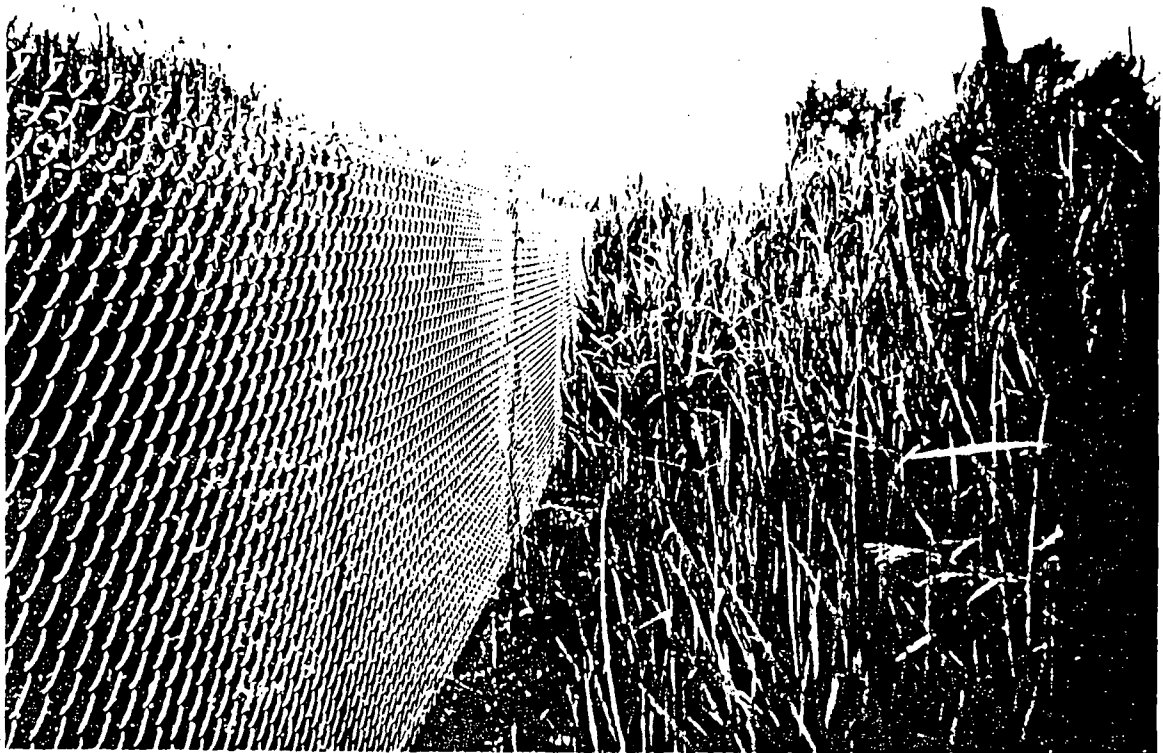
PHOTO-14

PHOTO 14 (P-14) VIEW WITHIN DRAINAGE SWALE WITHIN THE SOUTHERLY BOUNDARY OF THE SITE SHOWING TYPICAL HABITAT CONDITIONS WITHIN WETLAND AREA 'C' AT THE SOUTHERN BOUNDARY. LOOKING TOWARD THE SOUTHWEST CORNER OF THE SITE.

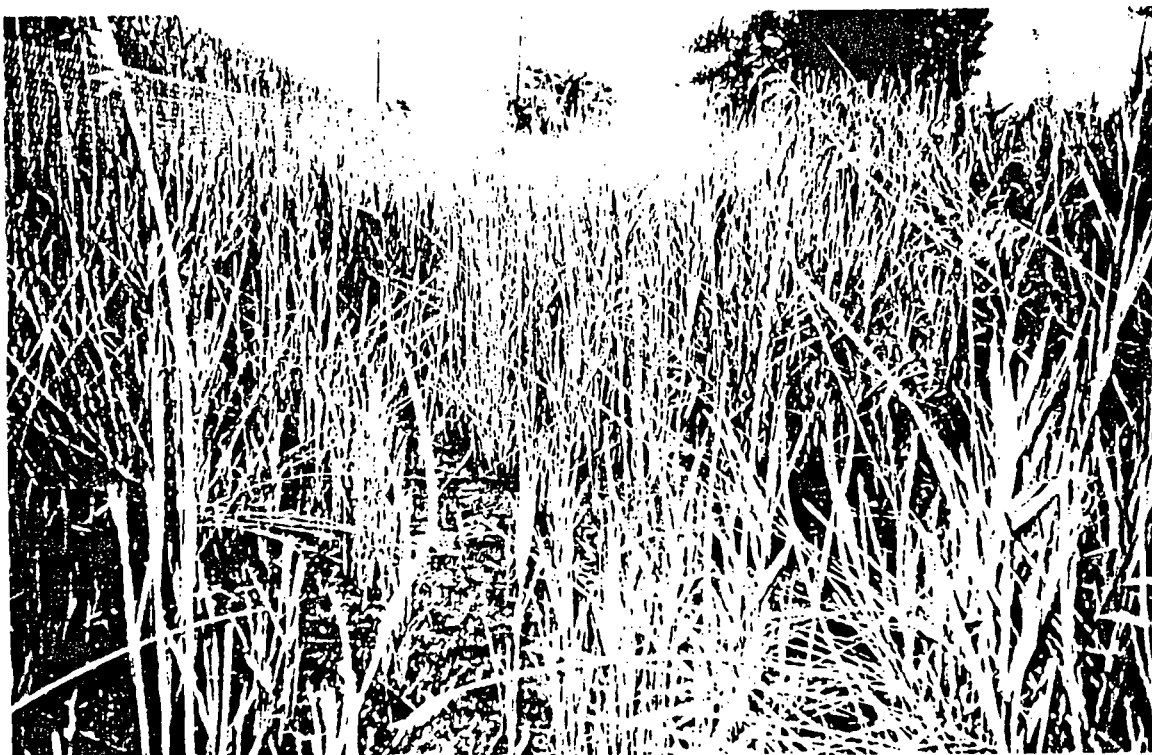
PHOTO-15

PHOTO 15 (P-15) OPPOSITE DIRECTIONAL VIEW OF THE SOUTHERLY PORTION OF THE DRAINAGE SWALE LOOKING TOWARD THE HEADWATER AREA OF THIS DRAINAGE CORRIDOR.

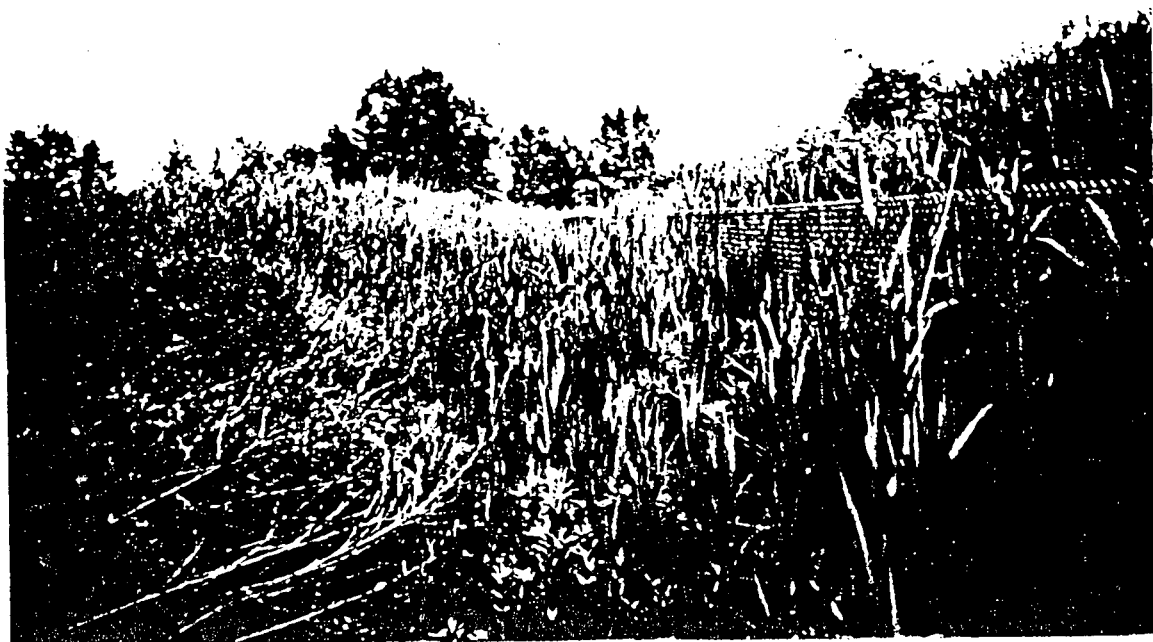
PHOTO-16

PHOTO 16 (P-16) OPPOSITE DIRECTIONAL VIEW OF THE SOUTHERLY PORTION OF THE DRAINAGE SWALE LOOKING TOWARD THE HEADWATER AREA OF THIS DRAINAGE CORRIDOR.

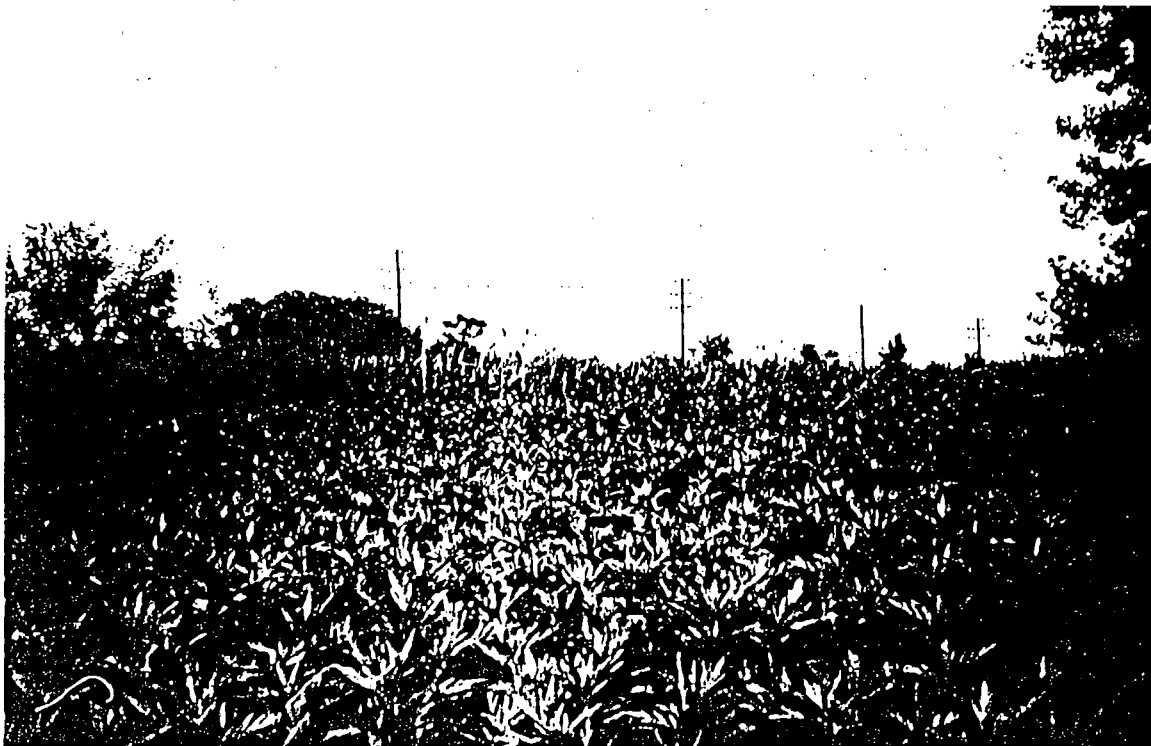
PHOTO-17

PHOTO 17 (P-17) NORTHWESTERLY VIEW WITHIN UPLAND FALLOW FILL AREA LOOKING TOWARD THE WESTERLY PORTION OF THE DRAINAGE SWALE PARALLELING THE WESTERLY BOUNDARY OF THE SITE WITH THE ELECTRIC R.O.W.

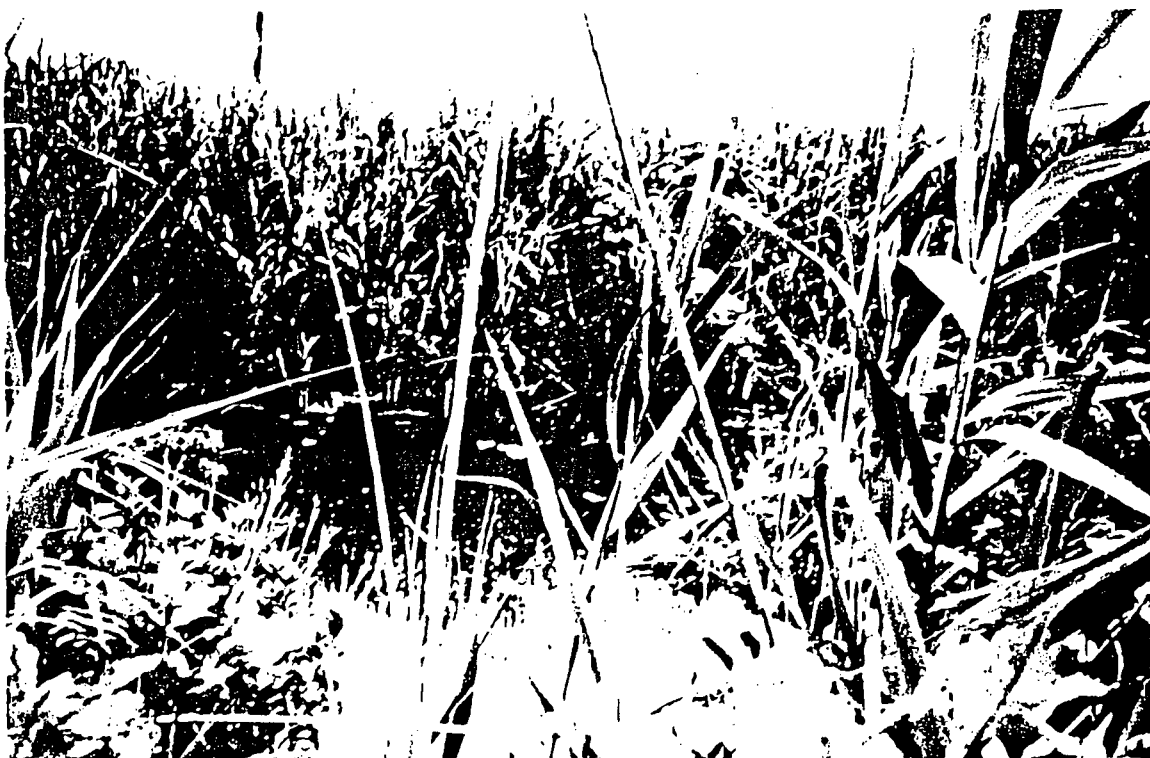
PHOTO-18

PHOTO 18 (P-18) WESTERN VIEW OF CONDITIONS OF DRAINAGE SWALE ALONG THE WESTERN BOUNDARY OF THE SITE SHOWING INTERMITTENT PONDED AREAS SEPARATED BY OCCASIONAL FILL BERM. TAKEN ABOVE DELINEATED LINE NEAR FLAGPOINT C-36.

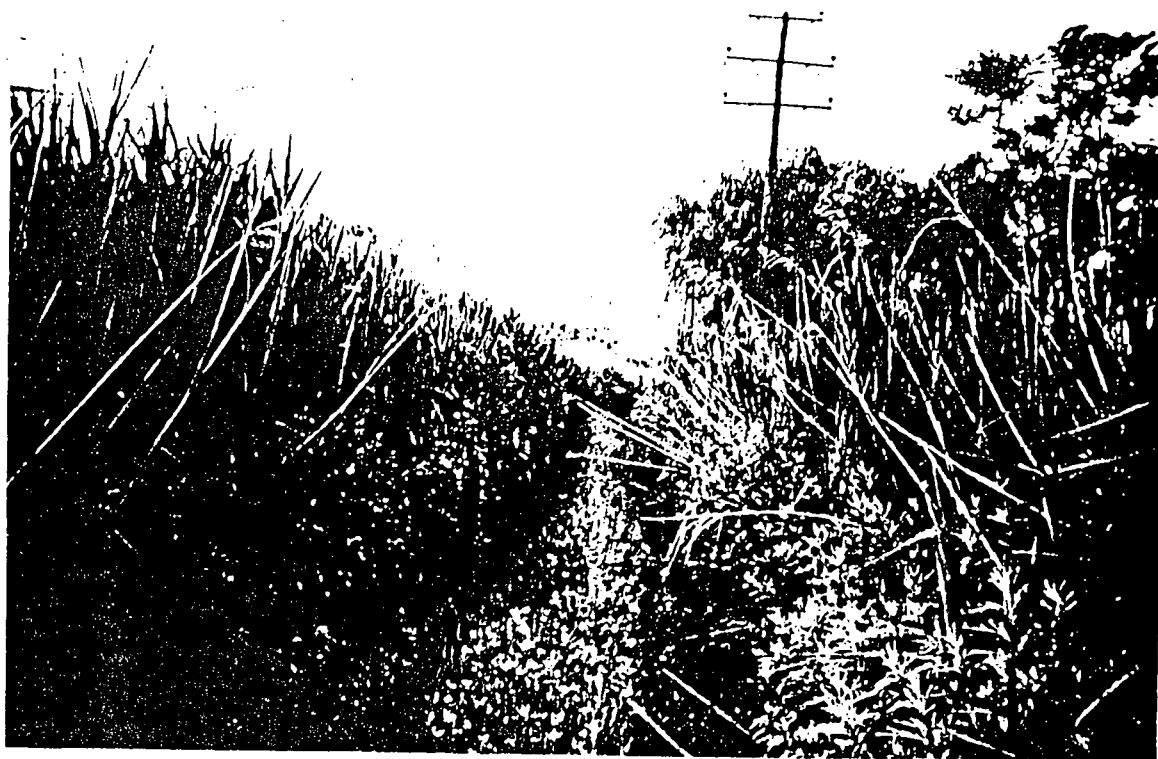
PHOTO-19

PHOTO 19 (P-19) NORTHERN VIEW TAKEN OUTBOUND WITHIN THE ELECTRIC CO. R.O.W. SHOWING TYPICAL CONDITIONS WITHIN THIS AREA OF THE SITE PARALLELING THE WESTERN BOUNDARY OF THE SITE RIGHT AND OUTBOUND OF VIEW.

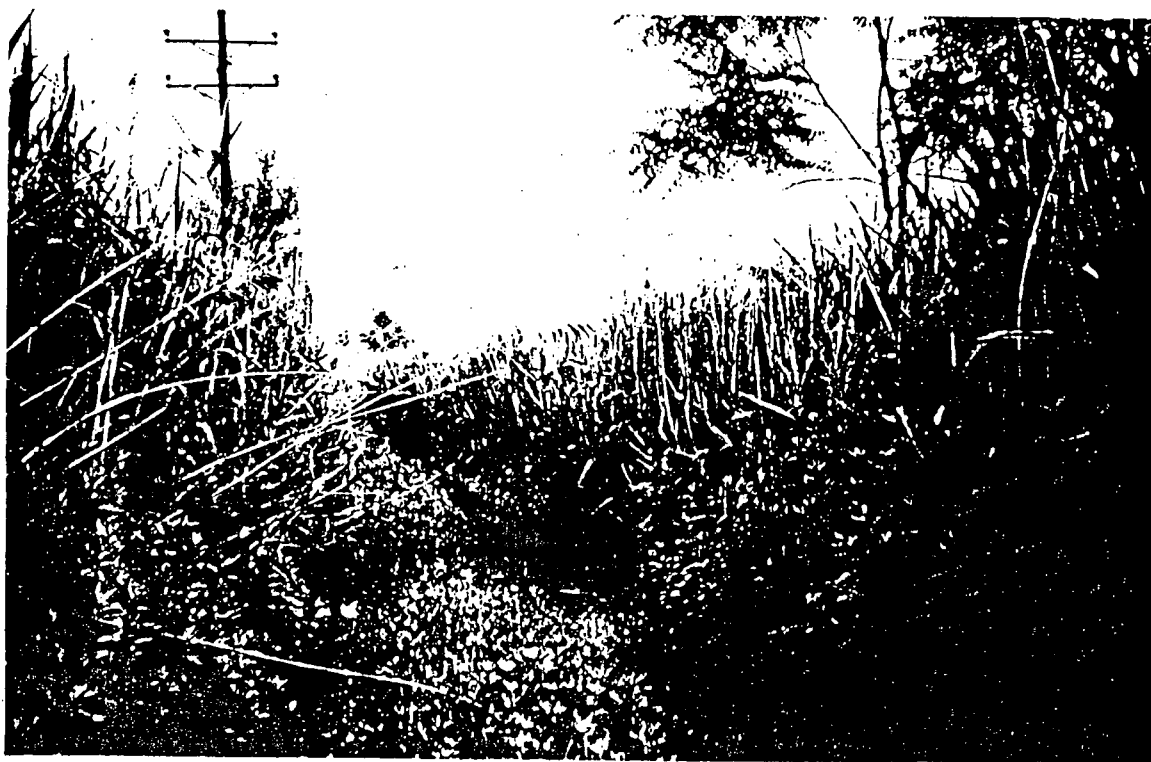
PHOTO-20

PHOTO 20 (P-20) OPPOSITE VIEW OF P-19 WITHIN R.O.W. LOOKING TOWARD SOUTHWEST CORNER OF THE SITE. SITE LEFT AND OUTBOUND OF VIEW.
